## ACCREDITED LABORATORY TEST REPORT No. 415600877-09

**Client:** SYNTEKO AB  
VAT: SE556571368101

**Subject of the test:** Extra 2K

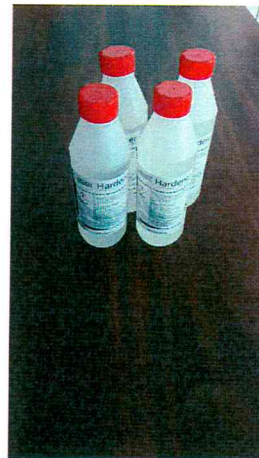
**Fig. 2: Hardener, ref. No. 415600877/7**

| ITC's identification number | Identification of the test Subject/sample by client | Description |
|---|---|--|
| 415600877/7 | Hardener | 4 plastic bottles with colourless liquid |
